Clinical News Corner

Successful retrieval of a disintegrated guide wire within the right atrium with the new AndraSnare device

References: Dr. Marc Kalinowski, MD; PhD Vice Chairmen Dep. of Diagnostic Radiology
Philipps University Hospital Marburg Germany

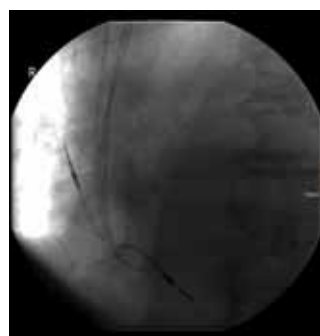
(Fig. 1)

Due to a thrombosed right internal jugular vein we had to use the sonographically patent left jugular vein. After ultrasound guided puncture of the jugular vein we inserted a 0.018-inch guide wire through the needle. Under fluoroscopy, guide wire placement into the inferior vena cava was difficult due to a sharp curve from the brachiocephalic trunc down into the superior vena cava. Additionally, the placement procedure was complicated by pacemaker leads inserted from the right subclavian vein. We decided to exchange the thin guidewire to a long 0.035-inch stiff type Amplatz guide wire to reach more pushability for placement of the peel away sheath and the tunnelled catheter. After preparing the subcutaneous tunnel we intended to place the tunnelled catheter. Unfortunately, the inserted guide wire could not be exchanged. Under fluoroscopy it was obvious that the guide wire was slipped back in the right atrium and the external circular coating was separated from the guide wire core and was ensnared either in a papillary muscle or the tricuspidal valve.

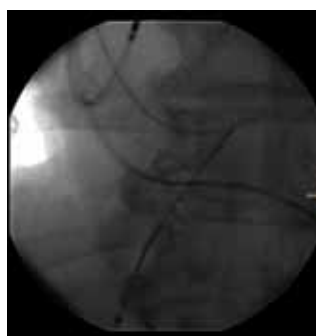
(Fig. 2)

Then we decided to cath the guiding catheter with a **AndraSnare AS 25** (25mm) catheter because of its excellent 3-dimensional captureability and small puncture site. Using a right femoral access and with only a short time of X-ray this manoeuvre was unsuccessful. Unfortunately, the guide wire could not be retrieved by this technique (Figure 2).

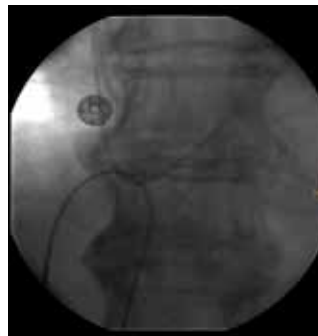
(Fig. 3)

We left the guiding catheter in the right atrium and decided to try and detach the guidewire from a additional femoral access site. We punctured the left common femoral vein. From the right femoral vein we inserted a Sidewinder catheter into the right atrium. We attached the tip of the sidewinder catheter over the guiding catheter (Figure 3).

Then we inserted a hydrophilic guidewire through the sidewinder catheter back into the inferior vena cava. From the left femoral vein access we used the **AndraSnare AS 25** (25mm) again, caught the guide wire and pulled the guide wire out of the left sheath. After that procedure we pulled simultaneous at both ends of the hydrophilic guide wire at the femoral access sides and at the guiding catheter at the jugular access side. After some attempts the fragmented guide wire could be released and removed in total. The patient had an uneventful follow up confirmed by heart ultrasound the next day. Two days later we implanted the tunnelled dialysis catheter without complications over the left jugular vein.
